# Navajo Abandoned Uranium Mine Site Screen Report

## Section 22 AUM Site

### Navajo AUM Eastern Region

**May 2009**

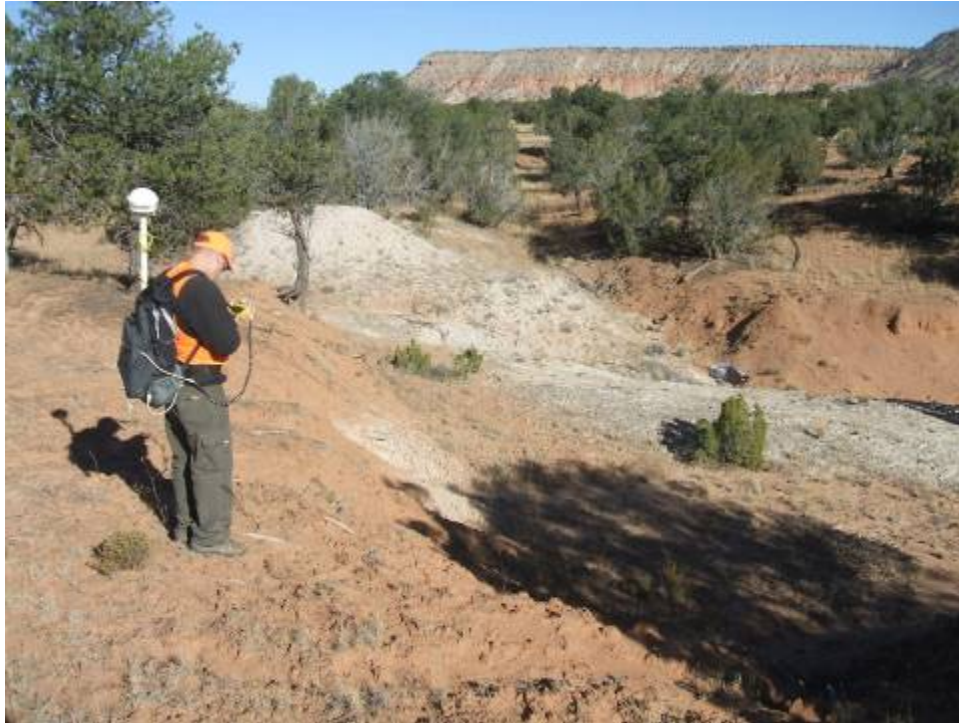
Photo 1. Section 22 mine site and gravel pile and ditch, towards the northwest

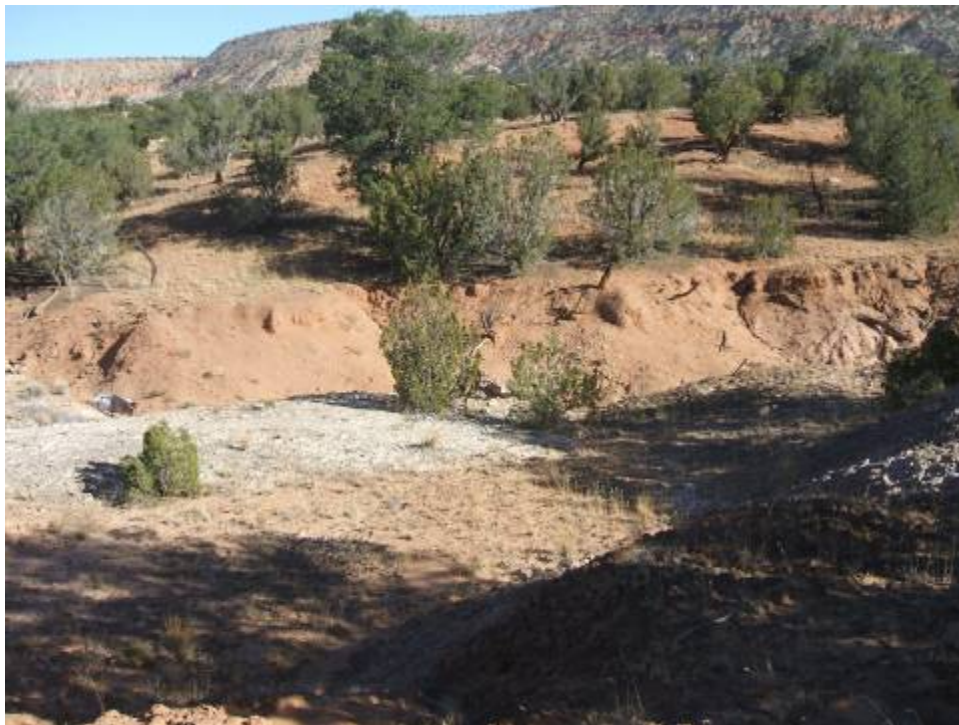
Reclamation status of the mine site is currently unknown. A small gravel pile was observed in the center of the site property (Photo 2). No adits or other mine features were observed during the site visit.

Photo 2. Section 22 mine site and gravel pile and ditch, towards the northeast

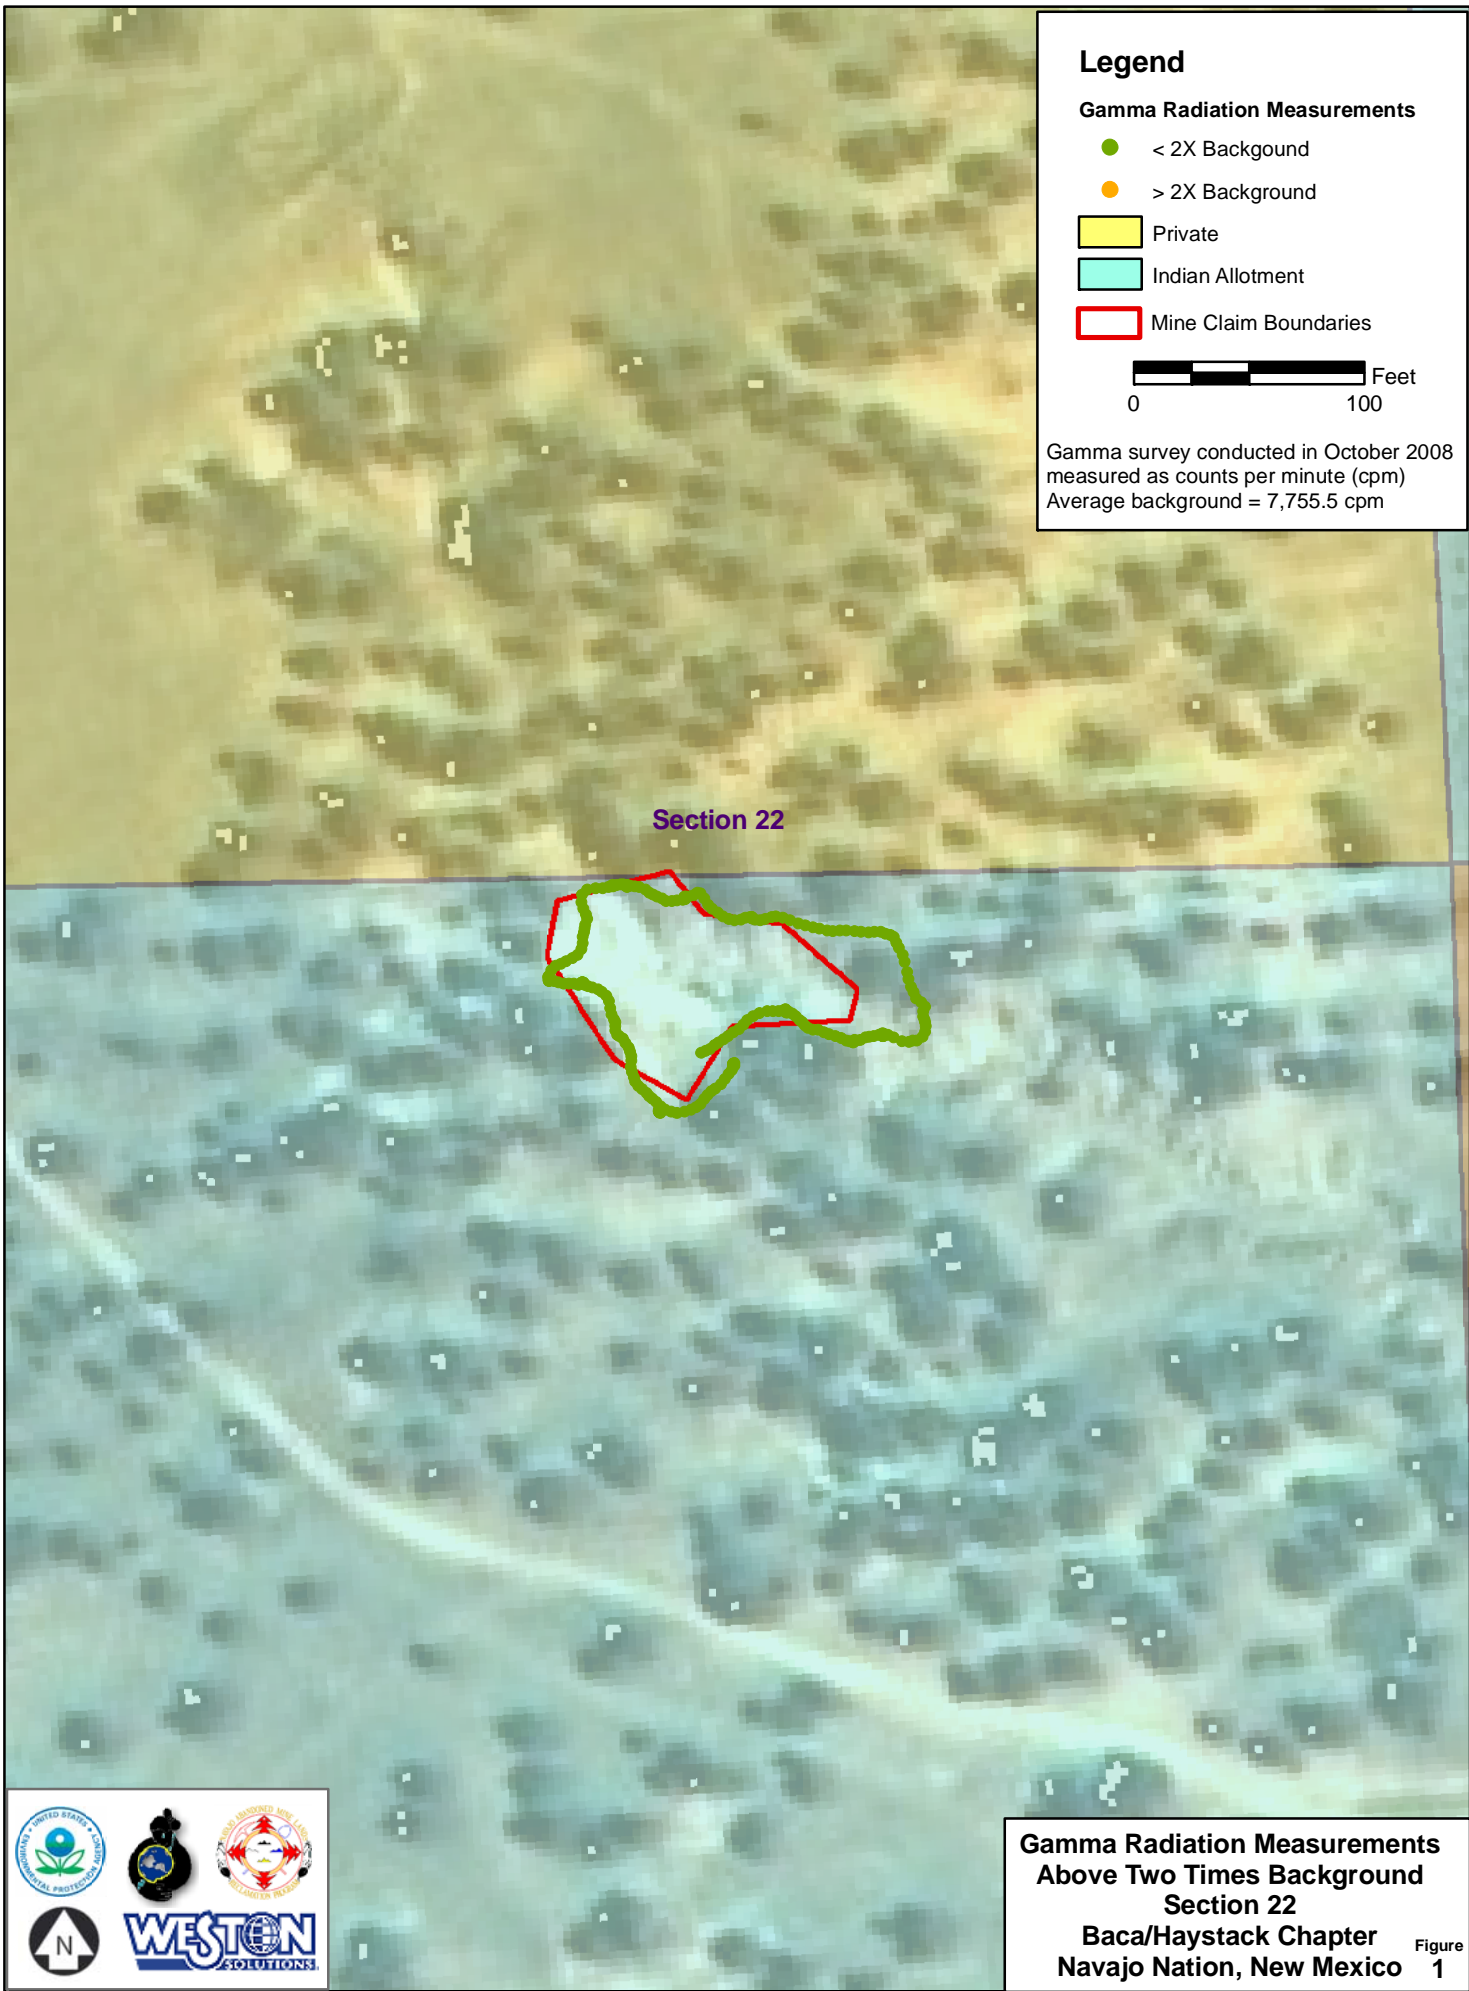
Figure 1

A total of 321 gamma radiation measurements were collected from mine sites, ranging from 6,245 cpm to 12,282 cpm. The measurements are represented in Figures 1 and 2.

**Gamma Radiation Measurements  
Above Two Times Background  
Section 22  
Baca/Haystack Chapter  
Navajo Nation, New Mexico**

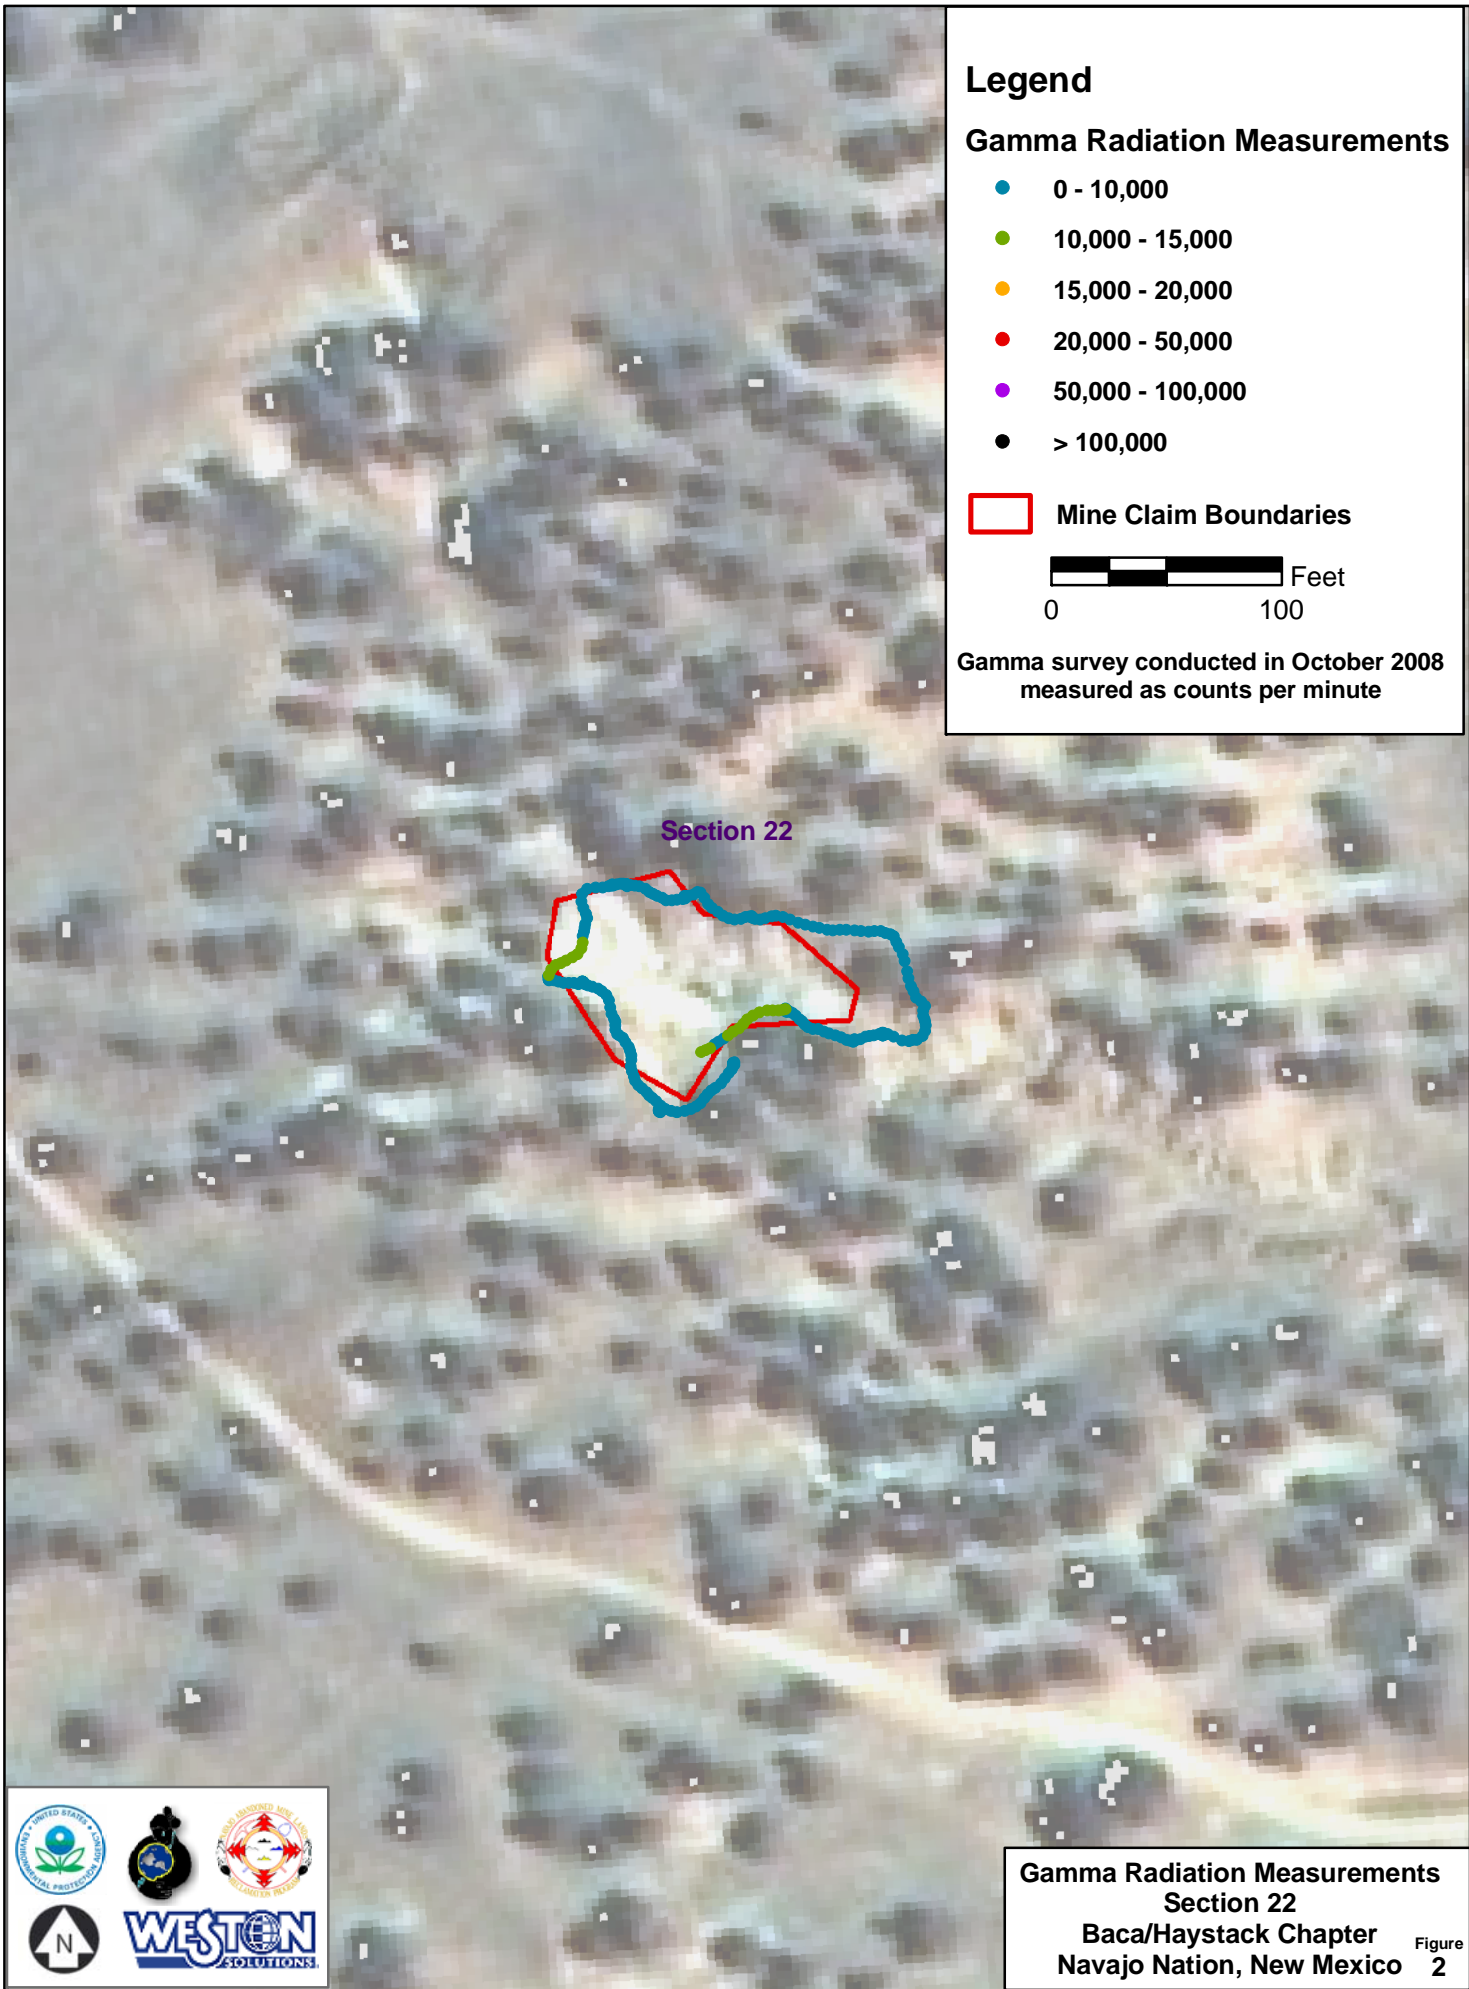
**Gamma Radiation Measurements**  
**Section 22**  
**Baca/Haystack Chapter**  
**Navajo Nation, New Mexico**
